Bodie Island Coast Guard Station Historic Structure Report

Cape Hatteras National Seashore
Bodie Island Coast Guard Station
Historic Structure Report

2005

By
Joseph K. Oppermann - Architect, P.A.
P.O. Box 10417, Salem Station Winston-Salem, NC 27108
336/721-1711 FAX 336/721-1712
joskopp@mindspring.com

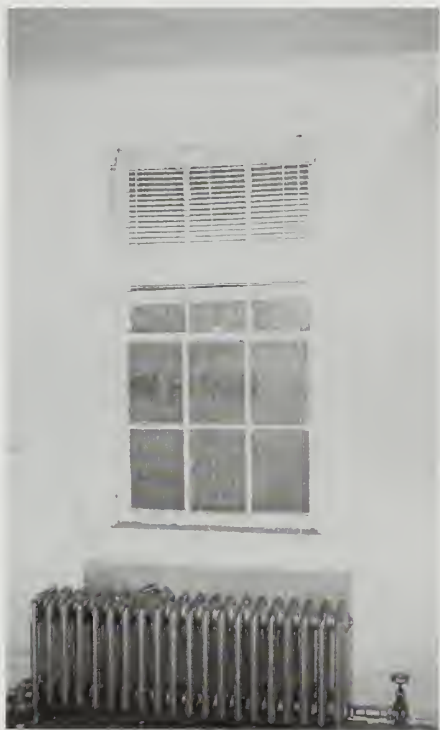
Figure C-7 Six-over-six window and radiator, probably both dating to 1925

Some of these windows have small amounts of rot or separated elements, and many have

broken sash cords, but in general they are in stable condition due in large part to the mothballing of the building.

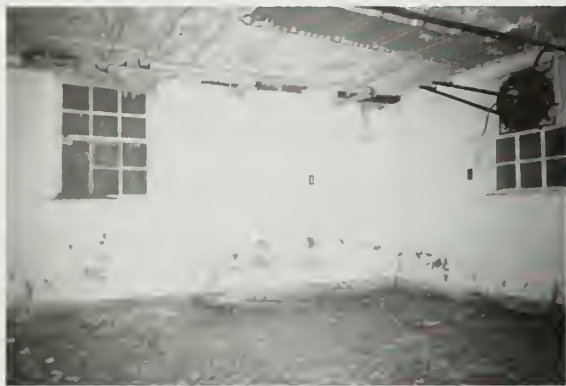
Figure C-9 Southeast corner of Room 001

- **Ceiling:** There is visible termite damage to the ceiling joists exposed in the southeast corner of the room and the adjoining east wall sill plate. The $9\frac{1}{2}$ " x $1\frac{3}{4}$ " ceiling joists are 16" on center and run east-to-west. An I-beam that runs from north-to-south for the length of the house is visible from the corner of the wall south of the staircase to the south

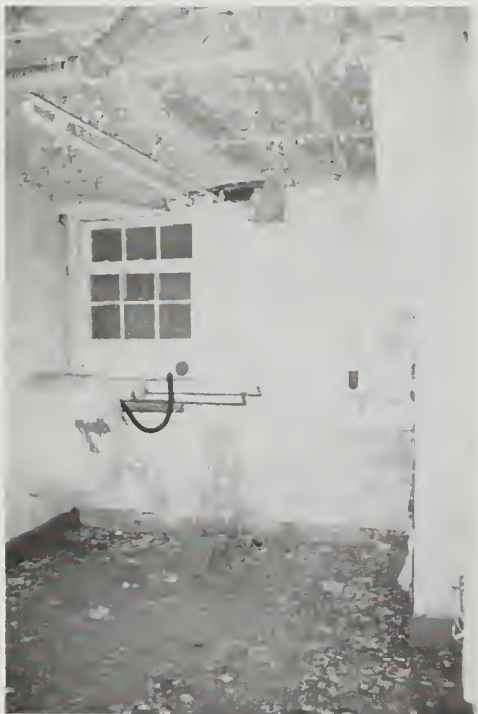
Figure C-15 Tank in Room 003

- *Other Features:* In the northeast corner of the room, part of the metal tank from the adjacent room is visible.

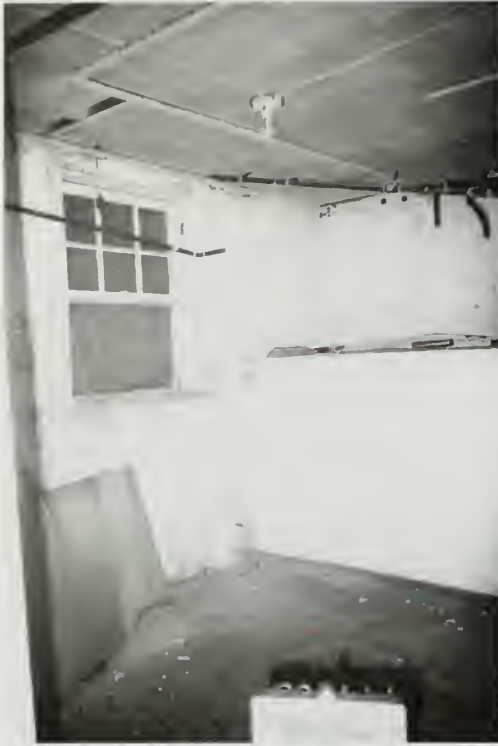
Figure C-16 Northeast corner of Room 004

- *Windows:* The room's one window, a six-over-six light window with Type M-1 muntins, is on the north wall and has the original 1925-vintage Type C-1 casings. Its

bottom sash is missing all three muntins and all of its panes of glass.

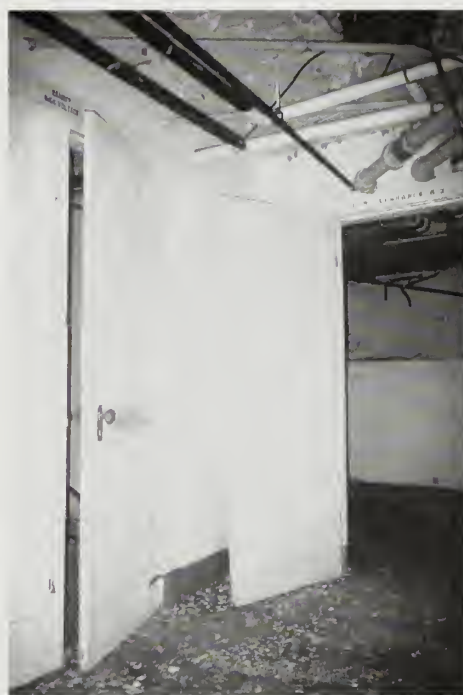
- *Doors:* The doorway from Room 004 to the boiler room (Room 006) has been lowered for overhead piping. The door casing is original, Type C-1, although cut down to fit the modified doorway dimensions. The door itself is made of plywood, a modern addition which probably occurred when the fuel oil system was installed.

Figure C-18 Reused 1925 double doors from Room 005 (L) and shortened doorway from Room 004 with modern door (R).

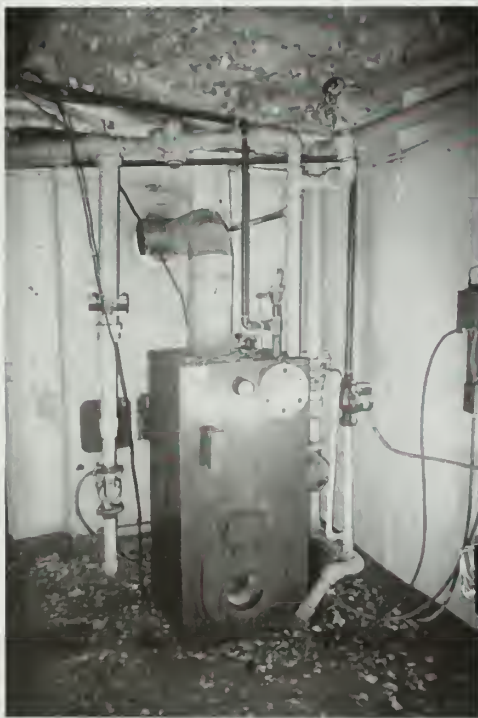
Figure C-19 Oil Boiler in Room 006

- *Ceiling:* The ceiling is sheathed with gypsum or plaster board.
- *Baseboards:* The east wall beside the chimney has the original, Type B-1 baseboard installed in 1933. The other walls have painted-on baseboard representations.
- *Finishes:* The walls, floor, ceiling, and trim are all painted and are peeling extensively.
- *Mechanical & Electrical Systems:* An inoperative oil boiler made by American

Radiator and Sanitary Corporation is in the southeast corner of the room. The model is A-3 # A35P series 1B J1. It is vented into the chimney with a 6" galvanized vent pipe. Production of this oil boiler stopped in 1968, when the company ceased operation. The company records no longer exist. The installation date is not known. The large fuel oil tank does not appear on the last NPS drawings of 1974. Electric wiring in flexible metal conduit is exposed on the walls. One ceramic ceiling light fixture is in place. In the northwest corner of the room is a Rheem

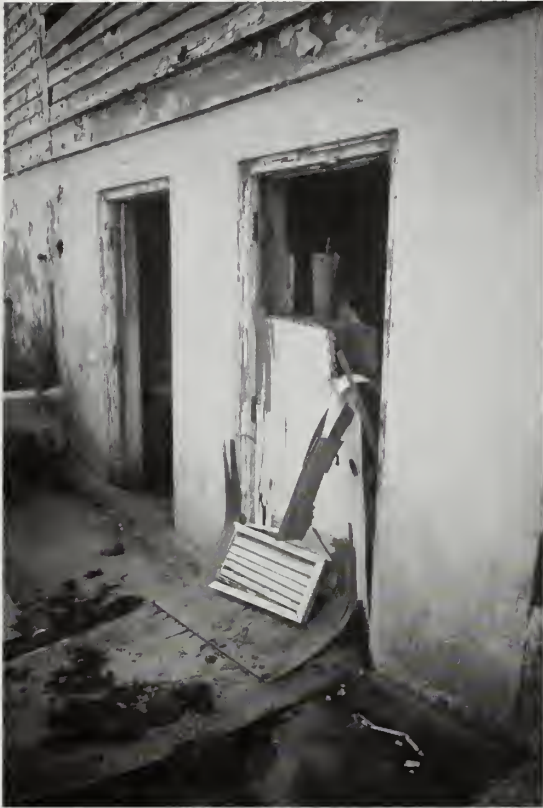
Figure C-22 Public Restrooms

stair tower was built in 1933. It has its original sash door with flush board surrounds. Two slab doors, also known as flush doors, on the north elevation provide access to the two restrooms. These doors are in very poor condition, having been damaged by termites.

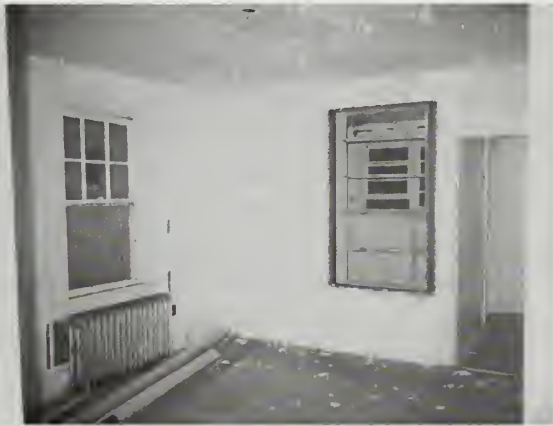
Figure C-23 Southeast corner of Room 101 with original window converted to an open bookcase

- **Windows:** The room's one remaining window, a six-over-six light, 1925-era window with Type M-1 muntins, is on the east wall and is missing all of its muntins on the lower sash. A second window opening on the east wall was closed in 1962 when the east addition was constructed. Cracks in the gypsum or plaster board interior wall patch still indicate its original location.

- **Ceiling:** The ceiling is sheathed with gypsum or plaster board and has extensive water damage.
- **Baseboards:** The baseboard along the east wall is the original, 1925-era Type B-3, as is the baseboard on the east side of the door to Room 112 and the north side of the door to Room 108. The baseboards in the southwest corner of the room between the two doors are 1925-era, Type B-4. The baseboards on the north wall are Type B-11 from a 1974 repair.

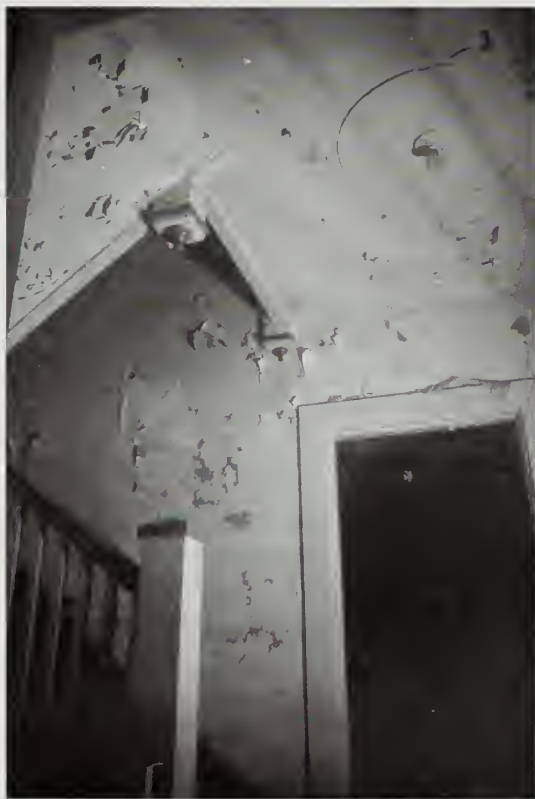
Figure C-24 Room 102 with plywood ceiling medallion and central light, staircase newel, balustrade, handrail, and pendants

- **Finishes:** The walls, ceiling, and trim are all painted and are peeling extensively.
- **Mechanical & Electrical Systems:** Surface-mounted wire molding is on the walls. The ceiling fixture is missing. There is one 1925-era cast iron 16-fin radiator with the dimensions 2'-1" x 3'-4" x 8" under the window. A galvanized, reflective heat shield is on the wall behind the radiator. There are two radiator pipes going up the east wall to the second floor.

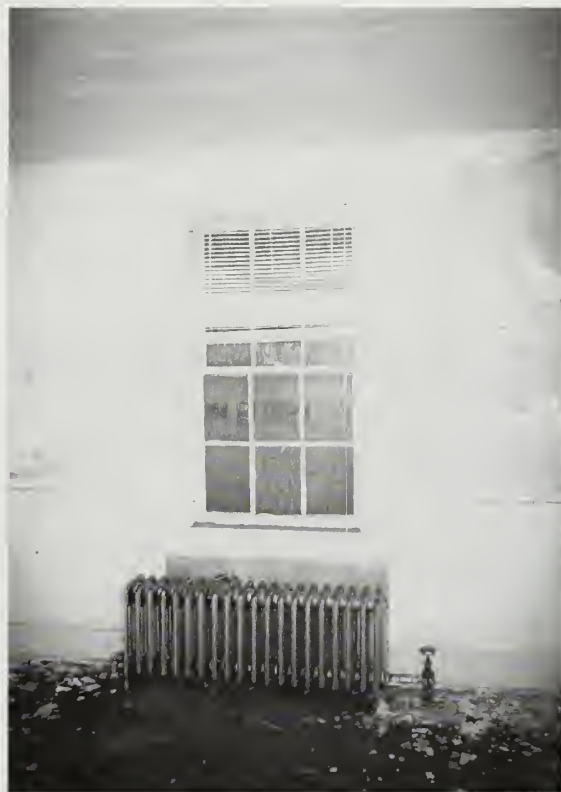
Figure C-25 Original window, Room 104

- *Windows:* The room's one remaining window is on the north wall and has the same 1925-era Type C-1 casing as the doors. It is a 1925-era six-over-six light window with 1925-era Type M-1 muntins. The window's bottom sash and top rail are cracked and out of alignment. One pane of glass is missing from the bottom sash.

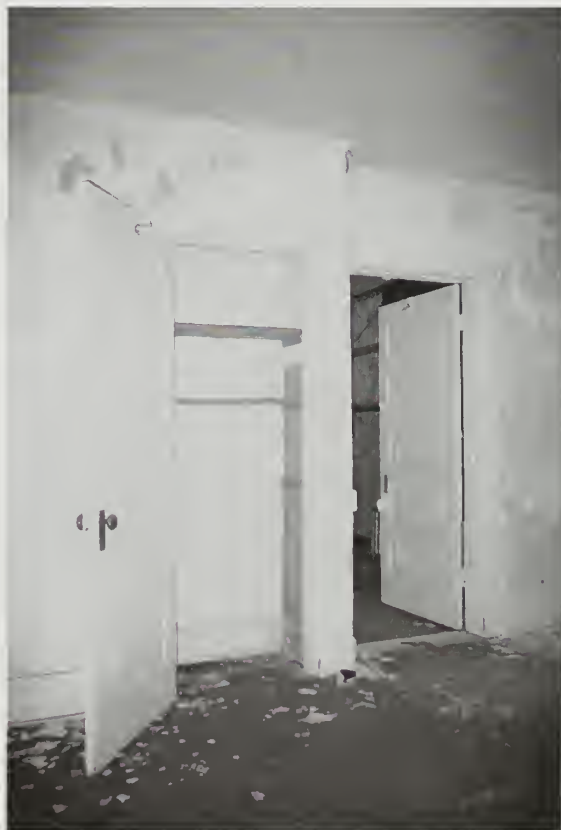
Figure C-26 Closet in Room 104

- *Other Features:* The room's one closet is located on the west wall just south of the door to Room 104. Original baseboards

were used to create shelves at some point. All three walls of the closet have 1925-era Type B-3 baseboards and early $\frac{3}{4}$ " quarter-round shoe moldings.

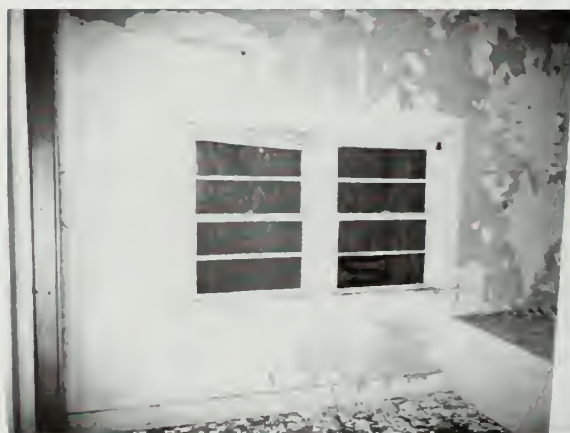
Figure C-29 Paired windows in the south wall of Room 109

- *Windows:* One pair of 1974-era two-over-two aluminum windows measuring 2'-4" x 3'-2" is on the south wall. It has 1974 Type C-11, mitered casing. One 1933-era four-over-four double-hung wood window with Type M-1 muntins and 1933 Type C-4 casing is on the west elevation.

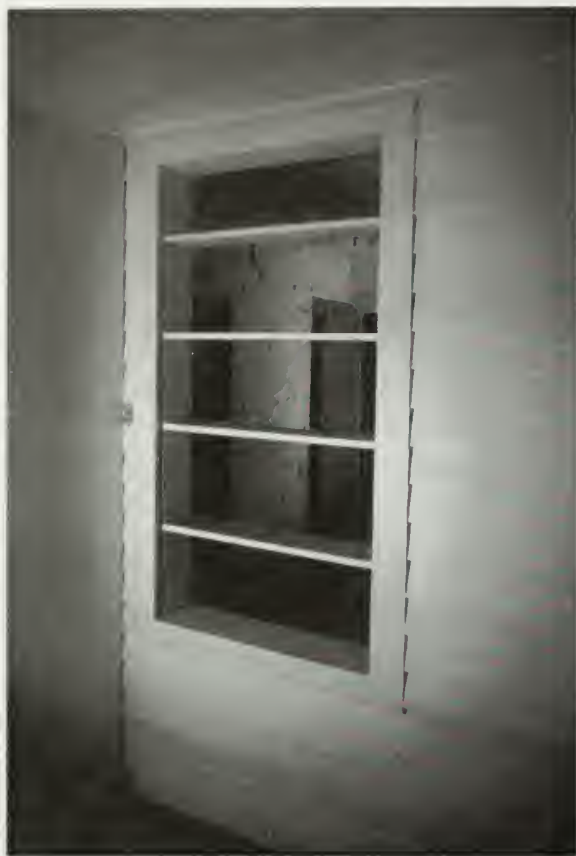
Figure C-31 Bookshelf created in original window opening in Room 111

- *Finishes:* The walls, ceiling, and trim are painted and peeling extensively.
- *Mechanical & Electrical Systems:* The room was lit by one fluorescent, ceiling-mounted light fixture.
- *Other Features:* An open bookshelf is located between this room and Room 101 in the original window opening on the north wall.

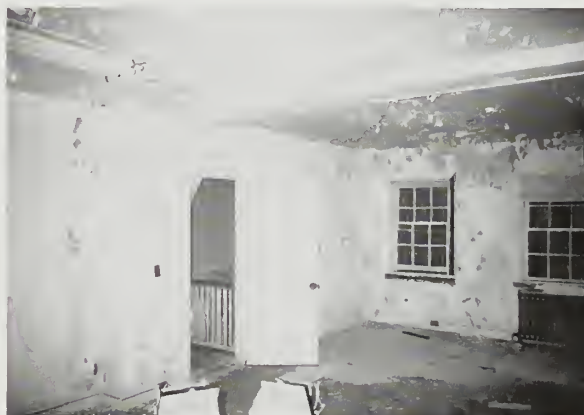
Figure C-33 Room 201

- *Flooring:* There is modern, commercial-grade wall-to-wall carpeting in poor condition in this room.
- *Walls:* The walls are sheathed with gypsum or plaster board on stud framing. There is a crack extending from the west corner of the doorjamb to the ceiling. Water damage is visible below the northernmost window on the east wall.
- *Doors:* The door from the stair hall, (Room 202) is a modern, hollow-core slab door that is 2'-8" x 6'-7". It has 1970s-era locking hardware and 3½", five-knuckle butt hinges. This doorway has 1933-era Type C-4 casing with mitered corners.

- *Windows:* The room's six windows are the original 1925 six-over-six Type M-1 windows, each with original Type C-1 mitered casings. All window units measure 3'-0" x 4'-6". The northernmost window on the east wall is missing its south section of casing, its apron, and two panes of glass. The southernmost window on the east wall has the bottom rail out of position in both sashes. The easternmost window on south wall is in good condition, while the westernmost is leaking above the lintel. The southernmost window on the west wall is missing one pane of glass from both the top and bottom sash. The northernmost window on the west wall is in good condition.

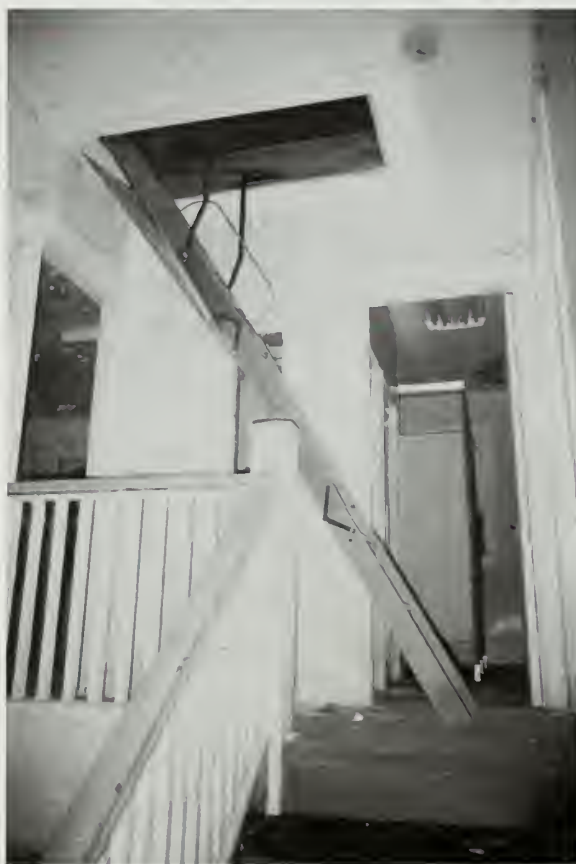
Figure C-34 Drop-down, folding attic stair in Room 202

- *Other Features:* The staircase has a plain 5" square newel post with a pyramidal cap. The balusters are 1" square and 3½" on center. In the ceiling in front of the door leading to Room 201 is a hatch framed with Type C-5 casing covering a 1970s-era drop-down folding attic stair. There are ghost marks of the earlier, presumably 1933-era ladder, on the hatch framing.

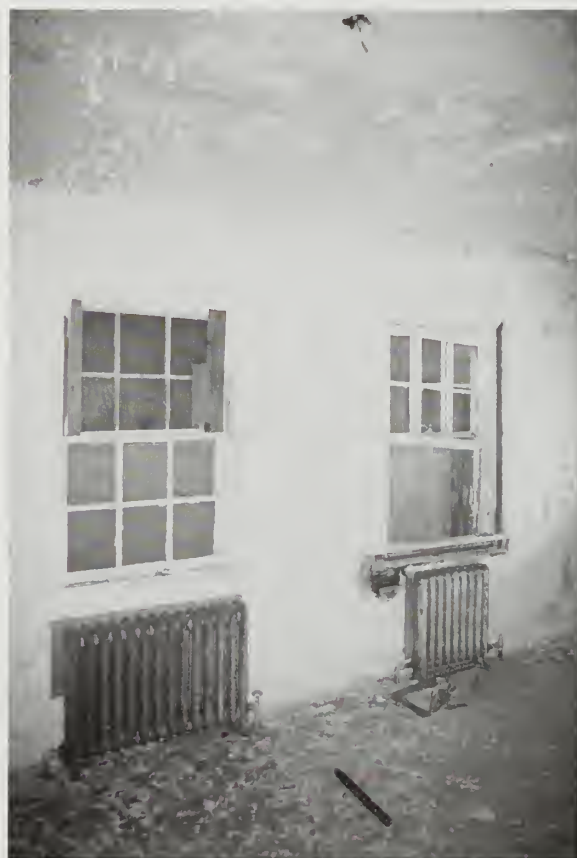
Figure C-35 Room 204

- *Windows:* The room's three windows, one on the north wall and two on the east wall, are the 1925 six-over-six Type M-1 windows. Both of the sashes are in place on the window on the north wall, but there is extensive water infiltration at the sill and damage to the wall below the window. The northernmost window on the east wall is missing three panes of glass from its top sash. The southernmost window on the east wall is missing a section of casing on the south jamb apron, its bottom rail is out of position, and its sash is out of square. The bottom sash is missing six panes of glass. This window also shows signs of water infiltration at the sill. All three windows have 1925-era Type C-1 casings.

- *Ceiling:* The ceiling is sheathed with gypsum or plaster board. It has a crack running east-to-west that corresponds to cracks on the east and west walls, and patches in the baseboards along those walls, where a dividing wall was removed in 1945.

- *Other Features:* A previous leak around the chimney stack has damaged the surrounding ceiling and associated wall elements.

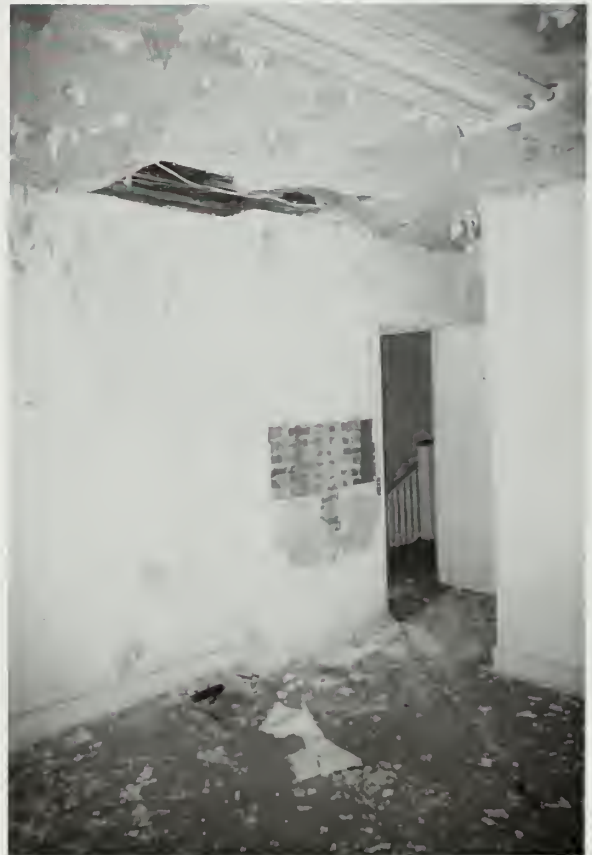
- *Flooring:* Modern, commercial-grade, wall-to-wall carpeting in poor condition is on top of 2¼" tongue-and-groove flooring laid north-to-south.
- *Walls:* The walls are sheathed with gypsum or plaster board. There is water damage to the walls in proximity to the chimney stack on the west wall. Water damage is also present below the windows on the west and north wall elevations.
- *Doors:* The one doorway accessing the room is from the vestibule (Room 203). The door casing is 1925-era Type C-1 with mitered corners. A 1970s-era, 2'-8" x 6'-7", hollow-core slab door now swings into the room. It has 3½" modern butt hinges; however, it is missing its modern locking mechanism.

Figure C-36 Chimney in Room 205

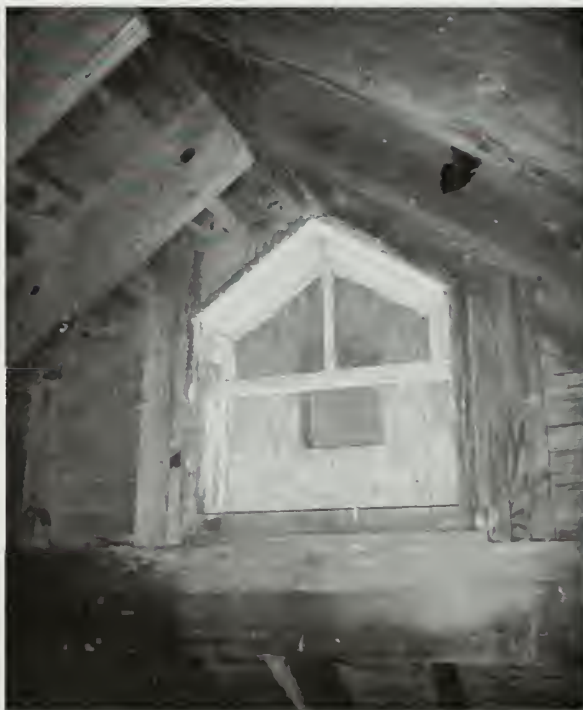
- **Doors:** None are present.
- **Windows:** The attic has two windows in small gables extending above the hipped roof, one on its north end and the other on its south end. Both the sash and subsill are out of place in the north window; water damage to the surrounding framing is visible. The south window's top sash is in

place; however, the bottom sash has been replaced with a ventilation cover. The original sash is stored in the attic. There is some water penetration and minor damage at the window's subsill.

Figure C-39 Window in attic gable
